# Notes on Thermal Aging in Inductor Cores

## Coilcraft's selection of materials makes thermal aging a non-issue

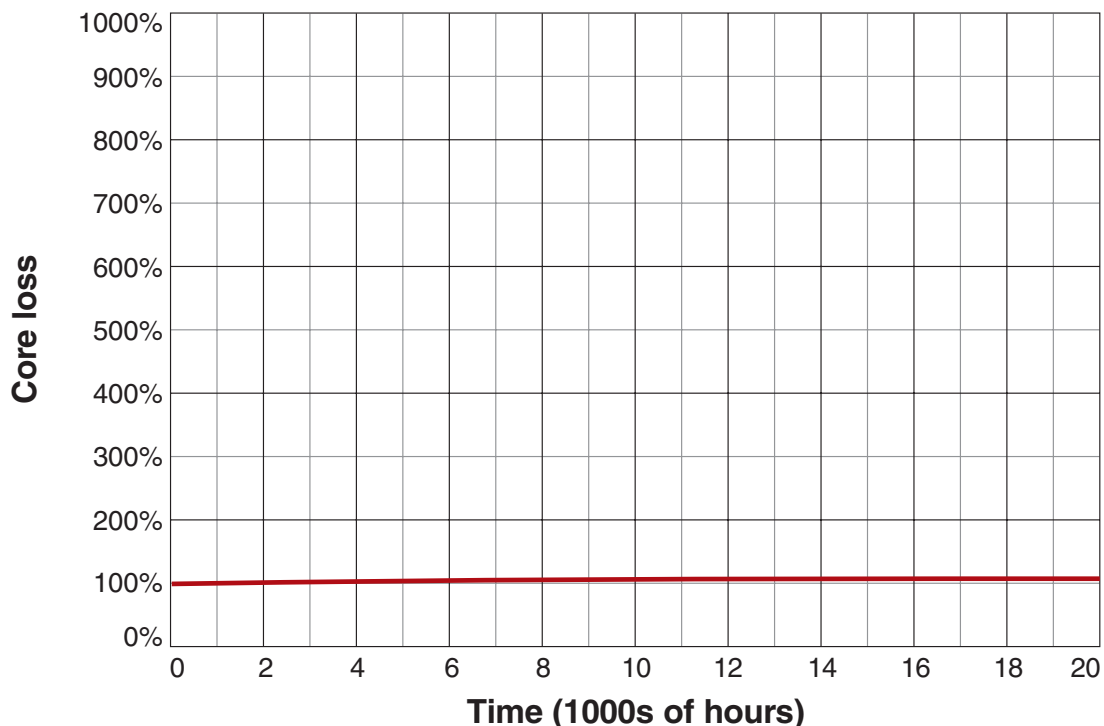
Figure 1. Coilcraft material shows little change after constant exposure to 165°C for two years.

Iron powder core materials have a proven record of reliable performance and value and are the core material of choice for a wide range of applications, even in high-temperature environments if suitable materials are used. Coilcraft XGL, XEL, XAL, XFL, PFL and XPL families (a.k.a. Ltra) use such materials and are not subject to the thermal aging phenomenon, as seen in the following figures. Core loss was measured after exposure to a variety of time and high temperature combinations. Figure 1 shows the stability of the material used in Coilcraft iron powder core inductors, with core loss stable after aging at 165°C for 20,000 hours. (Less than 5% change in two years at high temperature.)

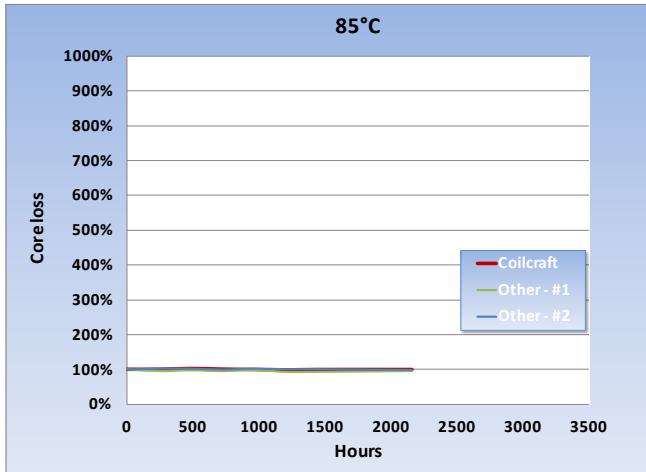
Figure 2. At 85°C core loss is stable for all three inductors.

The following figures show that other iron powder core inductors can exhibit dramatically degraded performance. Figure 2 shows stable core loss at 85°C for Coilcraft XAL7030-102 and two other commercially available iron powder core inductors. At 125°C, as shown in Figure 3, the core loss remains constant for the Coilcraft inductor, but shows a slight, increasing trend for the other inductors.

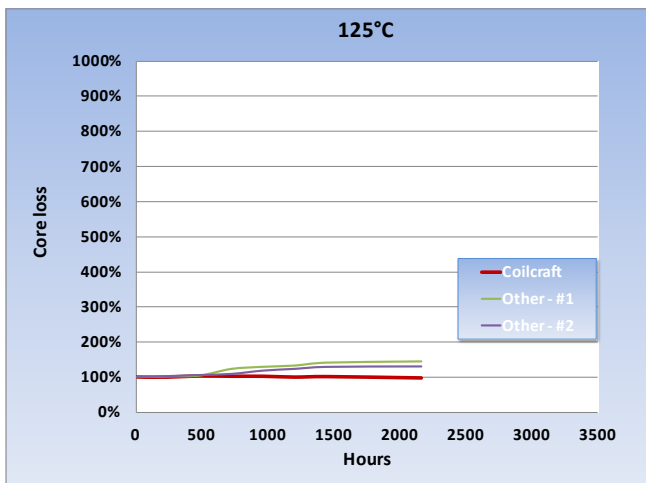
Figure 3. At 125°C only the Coilcraft inductor remains constant.

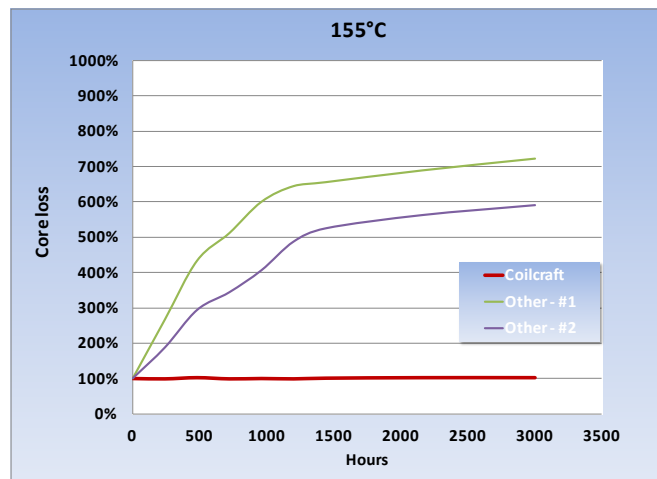
Figure 4. At 155°C the other inductors show dramatic core loss.

Figures 4 and 5 demonstrate the dramatic core loss increase caused by thermal aging. Both of the other inductors exhibit greater than five time increases in core loss after only 1500 hours at 155°C. The increase is even more dramatic for inductors aged at 165°C. In this case, one of the inductors has a core loss increase of nearly 10 times its original performance.

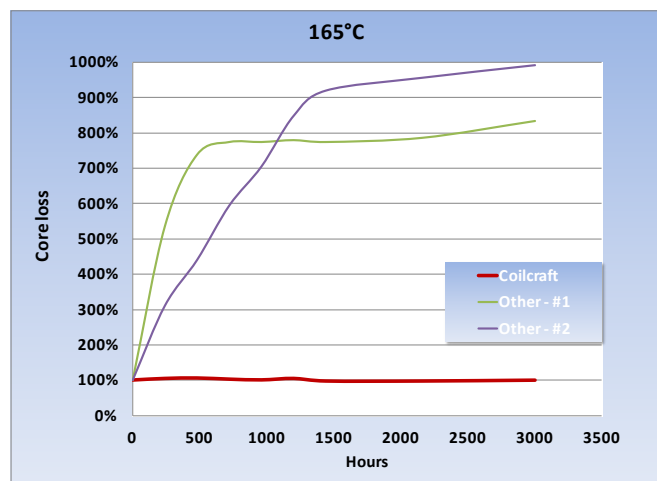
Figure 5. At 165°C one inductor shows an increase in core loss of nearly 1000%.
